No. 40,486-CA

COURT OF APPEAL
SECOND CIRCUIT
STATE OF LOUISIANA

H. H. HANKS, ET AL

ENTERGY CORPORATION, ET AL

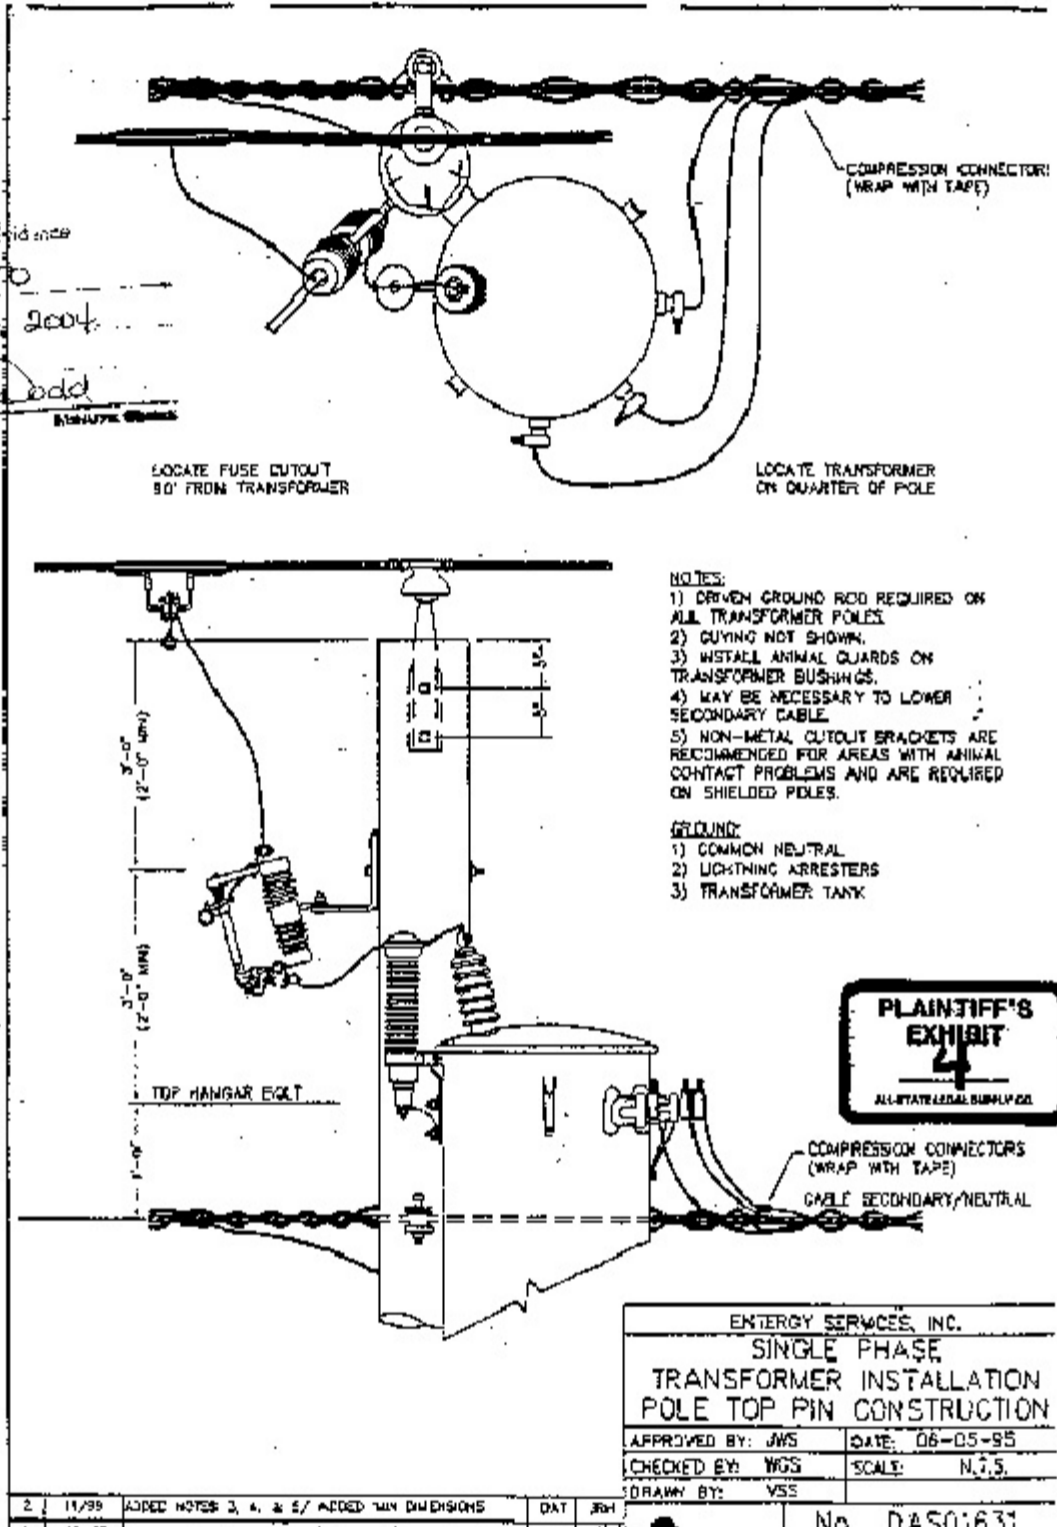
APPENDIX I

- NOTES:
- 1) DRIVEN GROUND ROD REQUIRED ON ALL TRANSFORMER POLES
 - 2) GUYING NOT SHOWN
 - 3) INSTALL ANIMAL GUARDS ON TRANSFORMER BUSHINGS
 - 4) MAY BE NECESSARY TO LOWER SECONDARY CABLE
 - 5) NON-METAL CUTOFF BRACKETS ARE RECOMMENDED FOR AREAS WITH ANIMAL CONTACT PROBLEMS AND ARE REQUIRED ON SHIELDED POLES.

- GROUND:
- 1) COMMON NEUTRAL
 - 2) LIGHTNING ARRESTERS
 - 3) TRANSFORMER TANK

The transformer, as explained in the trial testimony, is composed of massive windings which carry the current through wound electrical coils in a process to reduce the voltage. The high voltage charge from the H1 lead enters the transformer and meets the resistance of the windings. The over-voltage surge in this case, upon meeting such resistance, caused arcing through the transformer and the explosion. On the other hand, the description of the arrester did not include the use of such windings. The current would flow on the wire into and out of the arrester and directly into the transformer unless the switch device operated. Because the lightning’s current did not meet with the same resistance in the two devices, a comparison of the massive explosion of the transformer with the lack of explosion in the arrester was not shown by the evidence to be appropriate. Most significant, the configuration of the electrical path which the lightning’s current followed demonstrates that the same powerful current that destroyed the transformer flowed through the arrester without apparent damage. Clearly, Smith’s view that the problem was possibly a loose connection of the ground wire from the arrester at the clamp on the transformer’s tank, admits that the same destructive force of the current which was ultimately visited upon the transformer could have flowed

to the house. All three were grounded at the pole. Additionally, Brooks stated that there were two grounding connections on the tank of the transformer, so that Smith's identification of a possible loose clamp for the ground wiring at one of the connections on the transformer does not rule out the conduction of the current to ground at the pole. Thus, even with the lack of a ground function by the arrester as opined by Smith, he offered no explanation why the surge experienced by the transformer, even at only 20% of the lightning's strike, was not grounded entirely at the pole because of the grounding of the transformer itself. The pole was clearly the nearest source to ground for this lightning strike under either side's theory. Thus, with the evidence showing that the current which arced through the windings in the transformer could have been conducted through the ground connections on its steel tank, that undisputed ground source was apparently overwhelmed by the magnitude of the strike.
